NATIONAL ADVISORY COMMITTEE FOR AERONAUTICS

No. 1573

FLIGHT MEASUREMENTS OF THE FLYING QUALITIES OF
FIVE LIGHT AIRPLANES

By Paul A. Hunter

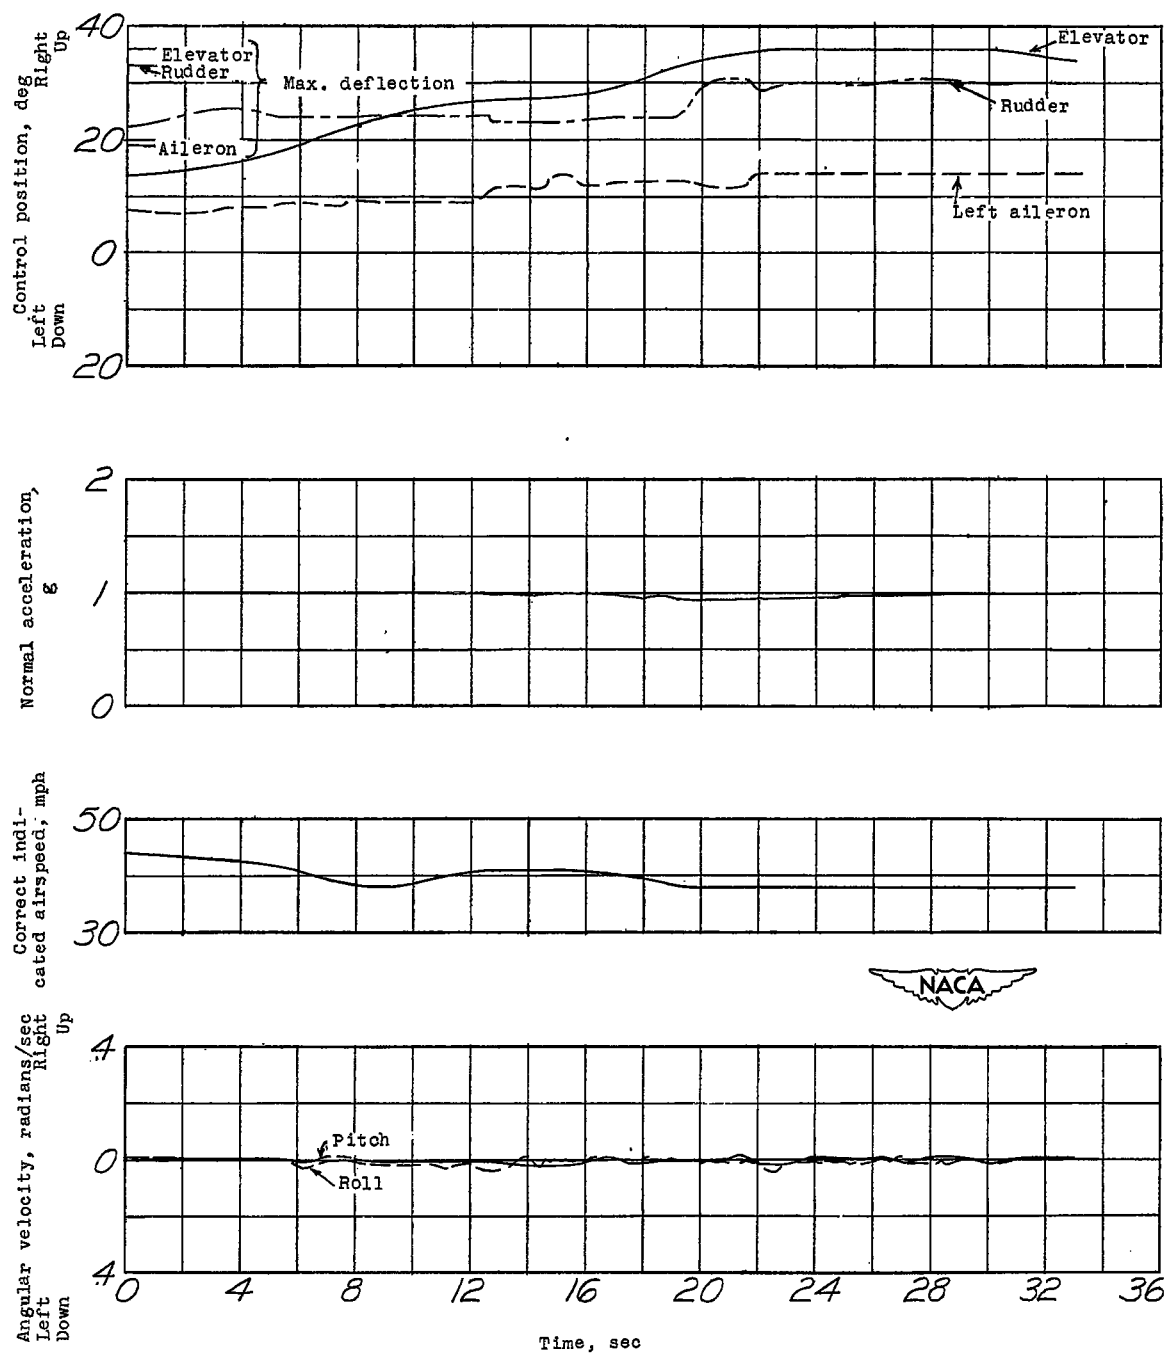
Figure 43.- Attempt to stall from power-off left sideslip. Note that full-up elevator does not produce lateral instability. Airplane 3.

In stalls carrying initial sideslip the relation between the up-elevator angle and the angle of attack for lateral instability changed from that which existed for straight unyawed flight so that greater amounts of up-elevator angle or more rearward positions of the stick were required to stall in every case. In the power-on conditions, the change in pitching moment produced by sideslip was not sufficient to prevent the complete stall. In these stalls the instability was increased in violence because the control disposition required for the sideslip carried corresponded to that used in spinning. The sequence of events when instability developed was a dropping of the downwind wing and a rapid turning toward the dropping wing because of the increased drag of that side as well as the sudden loss of equilibrium between the angle of bank and the cross-wind force. In every case the roll occurred in the direction opposite to the sideslip. These characteristics are shown in figures 41 and 42. In power-off conditions, sideslip angles of 20° so limited the effectiveness of the elevator that complete stalls could not be produced with the stick full back, as shown in figure 43; although with 10° sideslip, rolling instability could be produced.

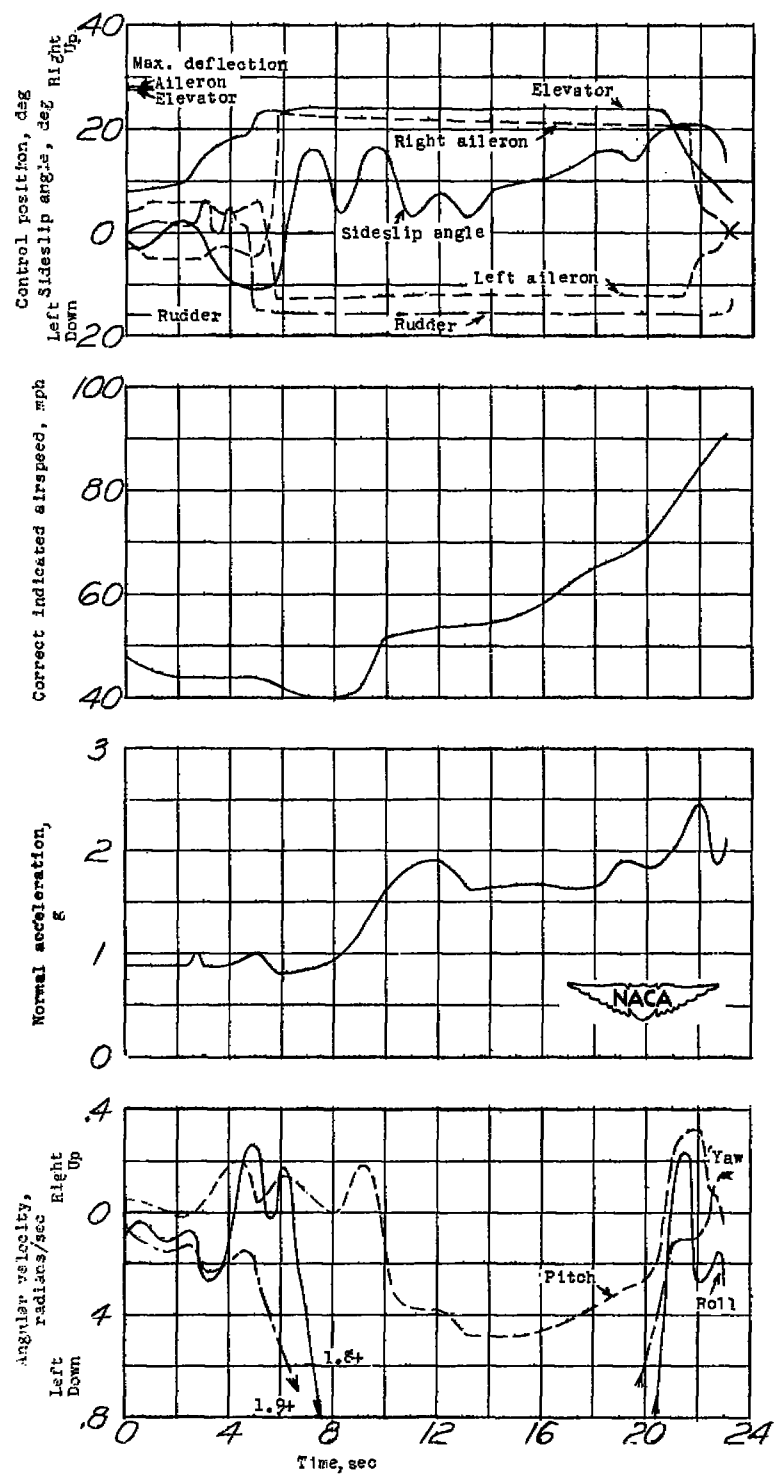
Figure 44.- Time history of entry and recovery from a spin. Flaps up; power on; airplane 4.

Recovery was rapid and automatic when the power was reduced or the controls were neutralized. A typical time history of a spin and recovery is shown in figure 44. All attempts to spin from other conditions resulted in spirals.

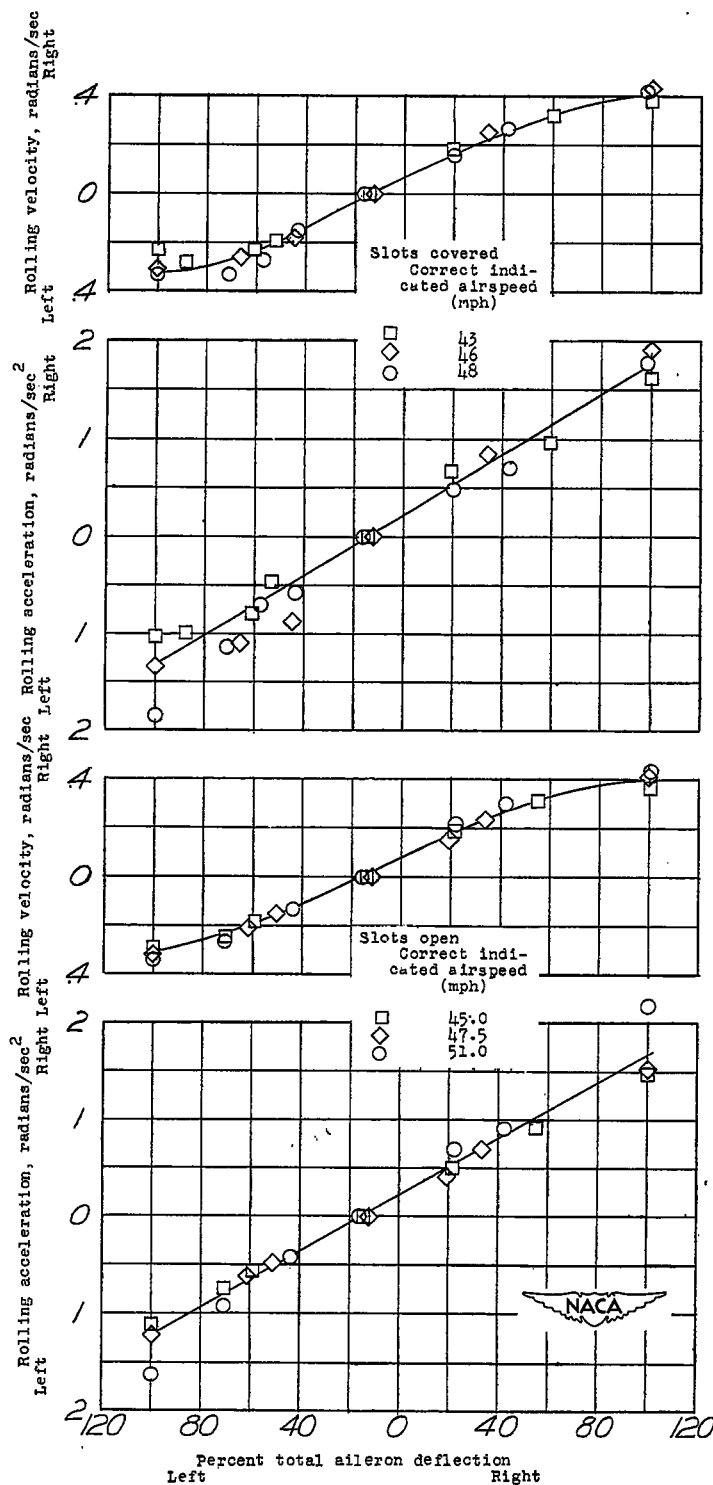
Figure 45.- Effect of slots on aileron characteristics. Airplane 4.

The characteristics specifically investigated were stalling, aileron effectiveness at speeds close to the stall, and longitudinal stability. Figure 45 presents comparable aileron-effectiveness data for both slotted and unslotted conditions. It will be noted that the slots had no measurable effect. Data on the longitudinal stability also showed an inconsequential effect. Although actual records are too lengthy to include, no measurable effect of the slots on stalling characteristics was discernible either to the pilot or through analysis of the data. The spinning data also remained unchanged.
